Metal detection only

QUICK REF. TEMP. ALTERATION : SET UNIT XQ-T2 - UNIVERSAL | art no. 8018464

DOC. ARTICLE NO: 5277922

DRAWING: T5277-922

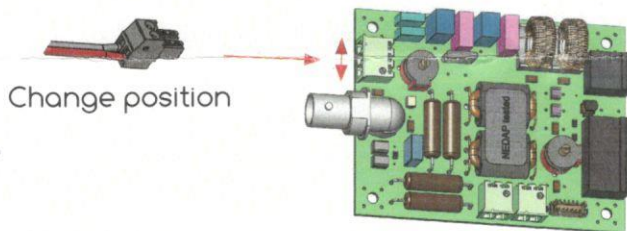
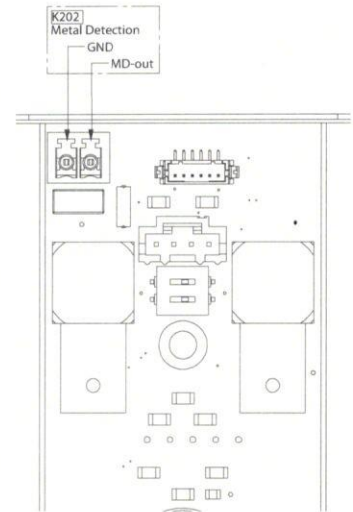
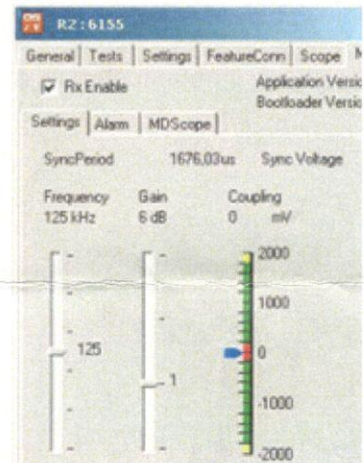
Due to a temporarily problem with availability of a component the connector K202 is mounted 180 degrees turned.

Due to this turning of the connector (K202), the field of the metal detection is also 180 degrees fase shifted.

This might be an issue during the adjustment of the system. During this adjustment you have to check the coupling of the metal detection. This must be between the 200 and 2000 mV (see picture).

This is only an issue when you have a MD-transmitter on both sides of a MD-receiver and the field of the both MD-transmitters is in counter fase.

Coupling in green area.

The measured direct coupling at the receiver Mixer (Vtop). The direct coupling has to be 200mV minimal. When the coupling is less than 200mV the Phase correction integrator does not function properly. The receiver will be blocked by the software and generate no alarms.

The solution is to change the fase with changing the position of the MD connection on the 50-ohm board.
